Effect of Thermal Impact Failure on Aluminum Alloy Piston Crown

Abstract—An analytical study of the thermal impact failure on a diesel engine piston has been performed in order to determine and analyze the possible causes of the failure. The piston is subjected to preliminary inspection, microstructure analysis and then hardness testing. Visual examination revealed the impact made by piston with valve head and the subsequent welding of the broken valve portion with the piston crown. It is observed to be caused by improper operating conditions. SEM and EDS analysis performed on the piston specimen revealed the presence of high alloy content and various intermetallics that precipitated in the Al-Si alloy material during combustion process. These particles are attributed for the high hardness and brittleness of the piston surface which thereby resulted in its fracture upon the impact. The weak boundaries between the intermetallics easily enable fatigue crack growth up to failure. Results from the microhardness test performed on the specimens validate the increase in hardness on the crown than on skirt. The analysis of obtained data and observations suggests that piston would have fai

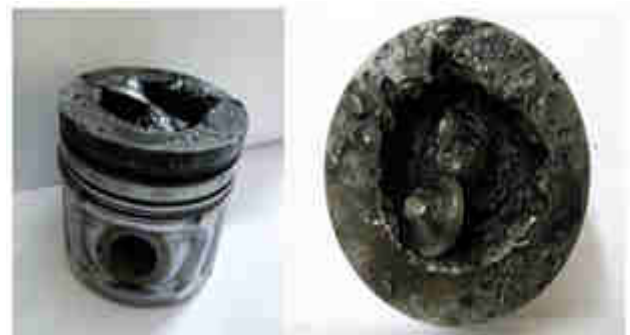
Here, an aluminum alloy diesel engine piston with damaged crown portion, as shown in Fig.1, has been undergone failure investigation by performing proper tests and subsequent analysis of results.

Fig.1: Piston with damaged crown portion.

The damaged piston contains a piece of valve being welded to the crown. The fractured crown portion indicates the severity of impact it had with the valve. During engine running, a piston is always at a red hot condition due to the peak combustion temperature (about 2000°C) at which the piston material could deform plastically [2]. Meanwhile, the valve is also experiencing high temperature (about 200-700 °C) and fatigue loading from combustion process which thereby weakens the material [4]. Under such conditions and because of the incorrect valve timing, piston makes impact with the valve at high velocity. Here, the valve is at a weaker state than the much harder piston material and the high pressure developed in this impact causes the valve head to break away from the valve body and get inserted into the red hot piston crown.

Indentations caused by the collision of piston with broken valve body and the fractured valve fragments trapped in the combustion chamber are also visible.

The high speed impact made by the red hot piston fractured the valve and got it welded to crown, which was in a near to plastic state. The impact was caused by the incorrect valve timing which is attributed to the factors such as incorrect valve fitting, spring failure, improper lubrication of valve and camshaft, slippage and rupture of timing belt/chain etc.

It is suggested that the piston failure by impact with valve could be prevented by ensuring the proper working of valve and camshaft systems. Also, failure by fatigue that would have occurred otherwise could be prevented by limiting the alloy content in the material.

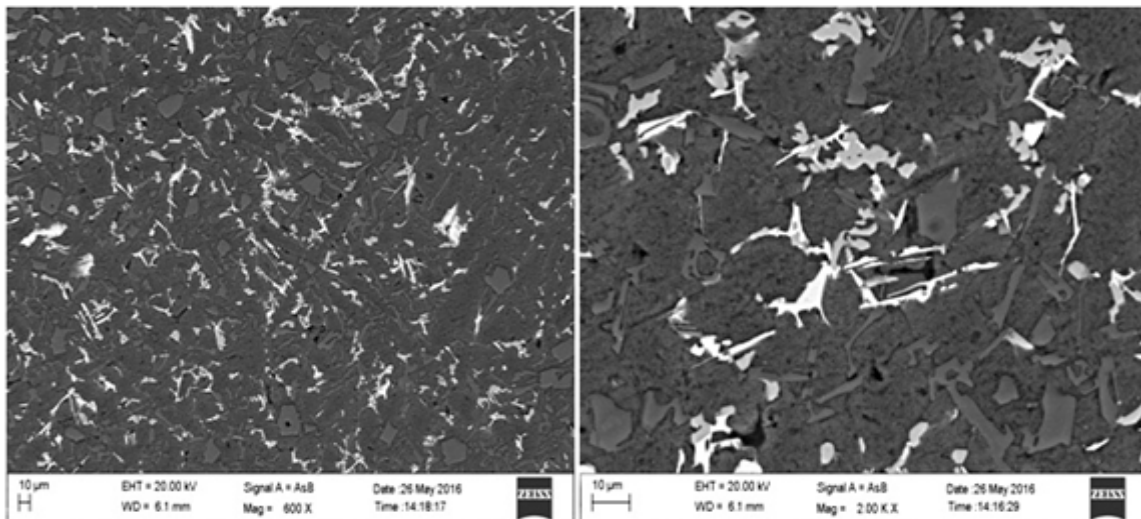
Fig. 3: SEM microstructure of Al-Si alloy

From the SEM images shown in Fig.3 and Fig.4, it can be seen that many intermetallics have been precipitated from the alloying elements in the piston during running at high temperature. The most common intermetallics include $\text{Al}_3(\text{CuNi})_2$, Al_5FeSi , Al_9FeNi , $\text{Al}_5\text{Cu}_2\text{Mg}_8\text{Si}_6$, $\text{Al}_8\text{FeMg}_3\text{Si}_5$ etc [5] [6]. These intermetallics are stiff and hard enough to deform in an inconsistent manner compared to Al matrix. The resulting stresses develop cracks that propagate further to form voids or pores as shown in figure. These pores could weaken the grain boundaries and interfaces between the intermetallics which enables the cracks to pass through them, thereby accelerating crack growth. The weakening of interfaces is attributed to the debonding or fracture of intermetallics and brittle Si particles that are in different orientations in the Al matrix [5] [6].

Such vastly distributed intermetallics precipitated out in the Al matrix makes the piston hard and brittle by reducing ductility. The increased brittleness beyond the limit could facilitate easy crack propagation and erosive fracture of particles from the surface upon the impact with valve head.

Thus, it is observed that the piston would have failed by fatigue cracking and fracture if the impact with valve has not occurred. In order to avoid the fatigue failure, the alloying element content in the material needs be reduced to the standard values as given in Table 1.

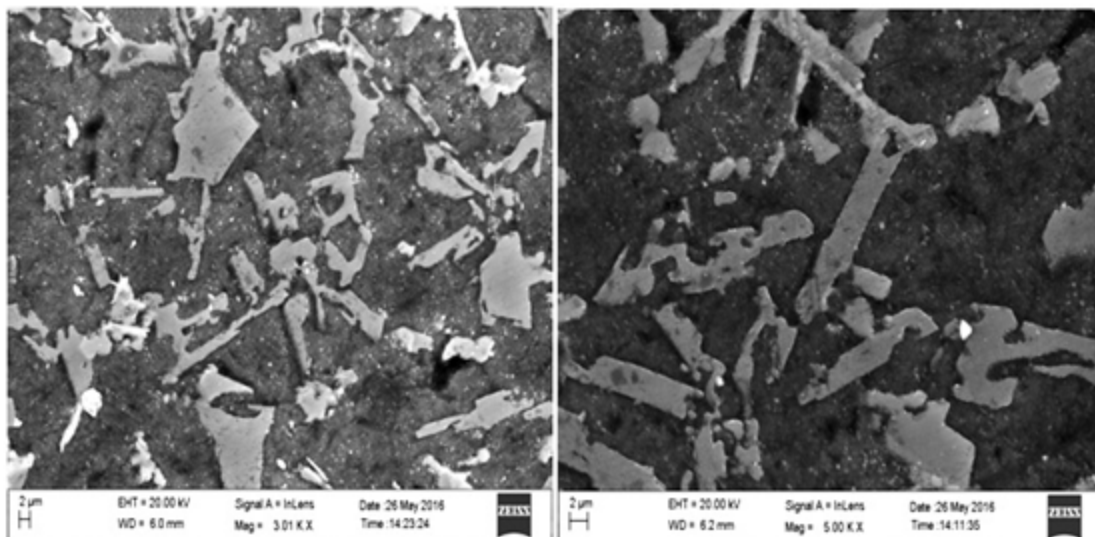
Fig. 4: SEM image of eutectic Si particles and intermetallics in different orientations
